Stream Inventory Report

Salmon Creek

Survey: Summer 2003
Final Report: September, 2004

California Department of Fish and Game
Central Coast Region
Watershed Restoration Program

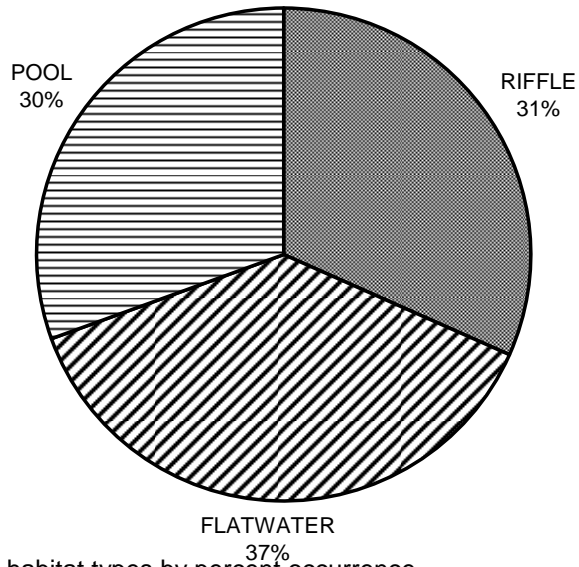
GRAPH 1. Level II habitat types by percent occurrence.

Table 1 summarizes the Level II riffle, flatwater, and pool habitat types. Based on frequency of *occurrence* there were 38.2% Flatwater units, 31.1% Riffle units, 30.5% Pool units and 0.2% Dry units (Graph 1). Based on total *length* there were 39% Pool units, 32% Flatwater units, 10% Riffle units and 0.1% Dry units (Graph 2).

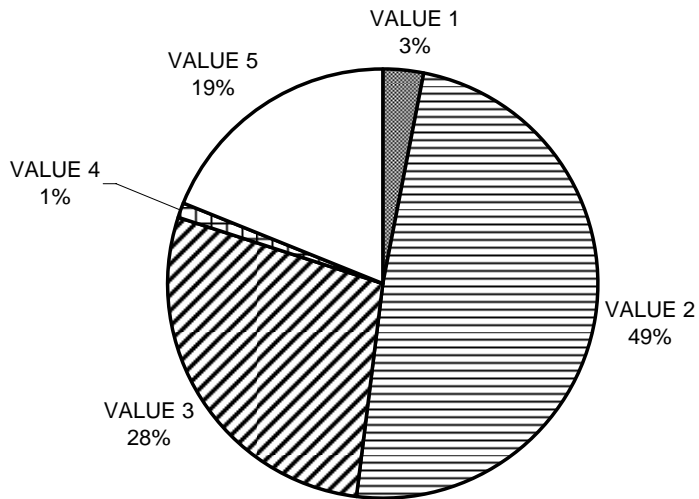
GRAPH 6. Percent embeddedness estimated at pool tail-outs.

The depth of cobble embeddedness was estimated at pool tail-outs. Of the 285 pool tail-outs measured, 9 had a value of 1 (3%), 136 had a value of 2 (48%), 81 had a value of 3 (28%) and 3 had a value of 4 (1%). 54 (19%) riffles rated a 5 (unsuitable substrate type for spawning). On this scale, a value of one is best for fisheries. Gravel was the dominant substrate observed at pool tail-outs (Graph 8). Graph 6 describes percent embeddedness of all pool tail-outs surveyed. No mechanical gravel sampling was conducted in 2003 surveys due to inadequate staffing levels.

Twenty nine percent of the pool tail-outs measured had embeddedness ratings of either 3 or 4. Only 3% had a rating of 1. Cobble embeddedness measured to be 25% or less (a rating of 1) is considered best for the needs of salmon and steelhead. In a reach comparison, Reach 9 had the best rating, Reaches 2,4,6, and 7 had fair ratings, and Reaches 1,3,and 5 had the poorest ratings. (Reach 8 had insufficient data).

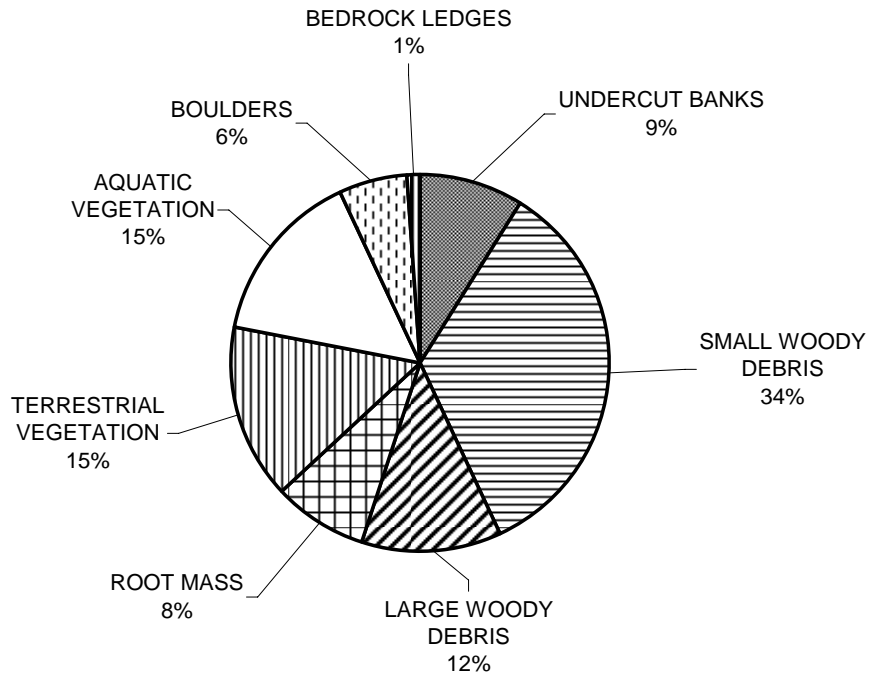
GRAPH 7. Mean percent cover types in pools.

Table 5 summarizes fish shelter by habitat type. By percent area, the dominant pool shelter types were Small Wood at 34%, Aquatic Vegetation at 15%, Terrestrial Vegetation at 15%, Large Wood at 12%, Undercut Banks at 9%, Root Mass at 8%, Boulders at 6%, Bedrock at 1%. Graph 7 describes the pool shelter in Salmon Creek.

The mean shelter rating for pools was 35, however, a pool shelter rating of approximately 80 is desirable. The relatively small amount of pool shelter that now exists is being provided primarily by Small Wood at 34%, Aquatic Vegetation at 15%, Terrestrial Vegetation at 15%, Large Wood at 12%, Undercut Banks at 9%, Root Mass at 8%, Boulders at 6%, Bedrock at 1%. Log and root wad cover in the pool and flatwater habitats would improve both summer and winter salmonid habitat. Log cover provides

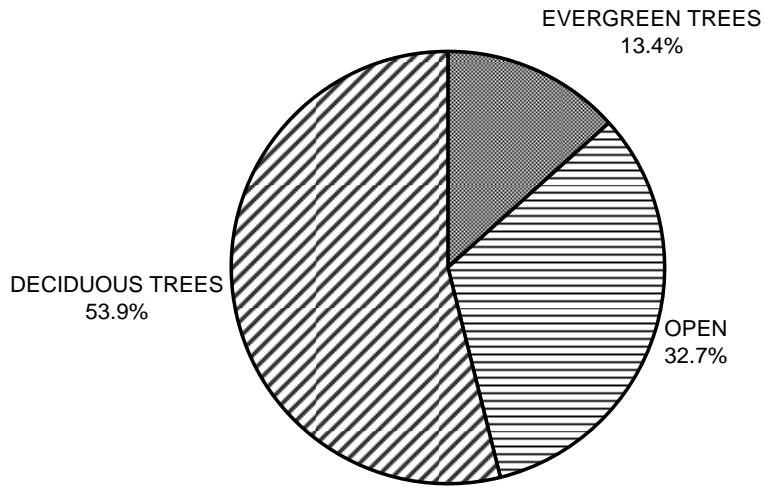
GRAPH 9. Mean percent canopy.

The mean percent canopy density for the stream reach surveyed was 67%. The mean percentages of deciduous and evergreen trees were 80% and 20%, respectively. Graph 9 describes the canopy for the entire survey and Table 7 summarizes the mean percent vegetative cover for the entire survey.

The mean percent canopy for the survey was 65%. This is a low percentage of canopy, since 80 percent is generally considered desirable. Although water temperatures in Salmon Creek are favorable to salmonids, increased canopy would eliminate hotspots that were observed in some reaches. Elevated water temperatures could be reduced by increasing stream canopy. The large trees required for adequate stream canopy would also eventually provide a long term source of large woody debris needed for instream shelter and bank stability. The riparian buffer is thin or nearly absent in some areas where livestock, agriculture and/or urban development exist. Riparian removal, intensive grazing and/or vineyard development within the riparian corridor could all lead to less stream canopy and channel incision causing bank erosion and higher water temperatures.

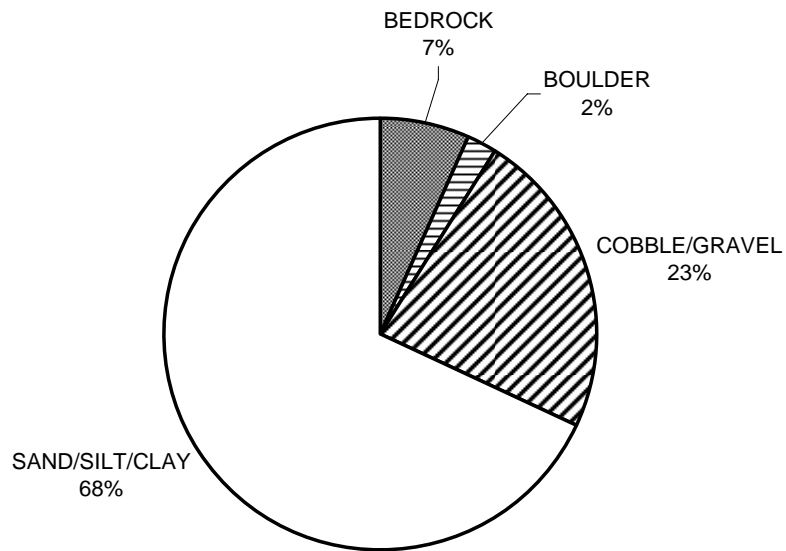
GRAPH 10. Dominant bank composition in survey reach.

For the entire stream reach surveyed, the mean percent right bank vegetated was 28% and the mean percent left bank vegetated was 26%. For the habitat units measured, the dominant vegetation types for the stream banks were: 51% Deciduous Trees, 18% Brush, 13% Bare Soil, 8% Grass and 8% Evergreen Trees (Table 8 and Graph 11). The dominant substrate for the stream banks were: 68% Silt, Clay & Sand, 23% Cobble & Gravel, 7% Bedrock and 2% Boulder (Table 8 and Graph 10).
