Gold Ridge Resource Conservation District

Upper Green Valley Creek Watershed Plan

The Upper Green Valley Creek Watershed Management Plan

Phase 1, June 2010

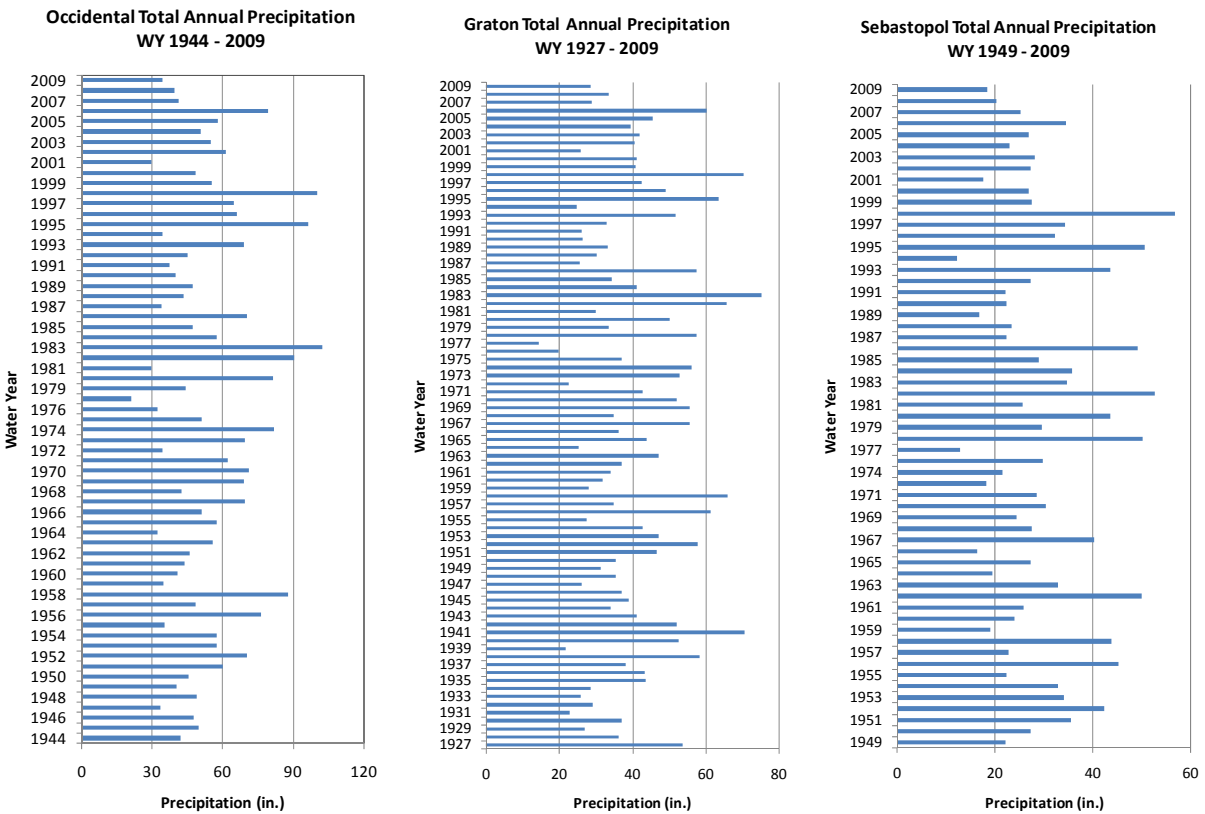
Chart 8 a-c. Distribution of annual rainfall at Occidental, Graton, and Sebastopol over long-term periods of record.

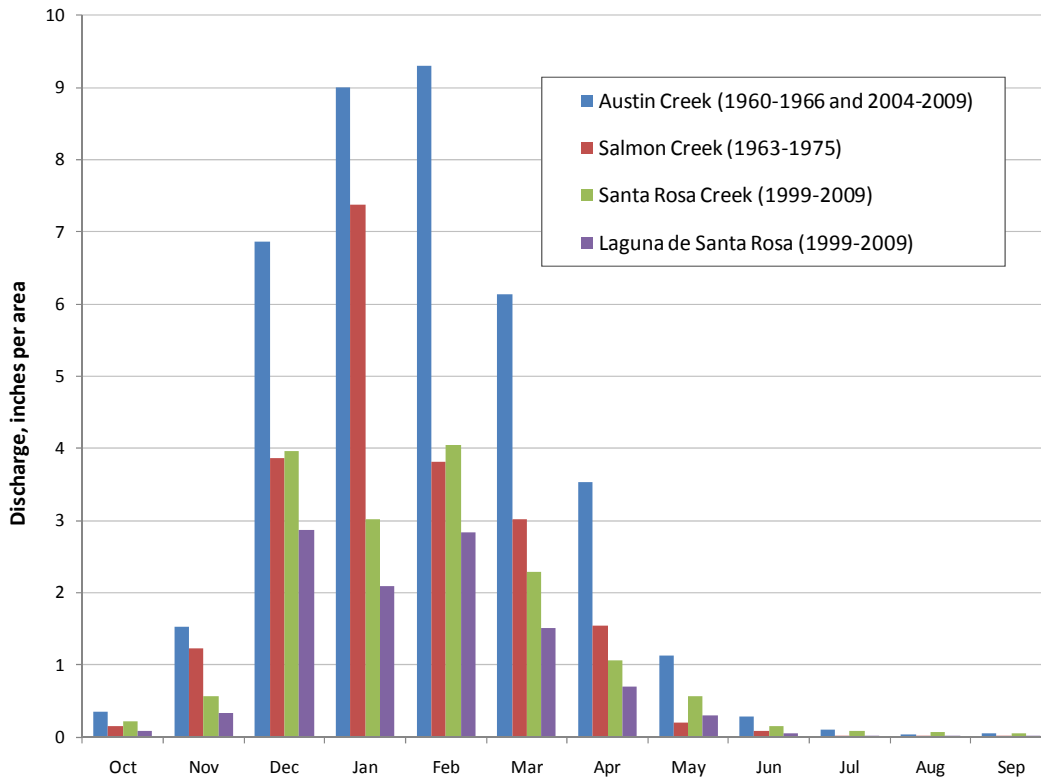
Chart 10. Average discharge from four streams near the GVC watershed, Sonoma County (as inches of runoff over the entire watershed).

Discharge follows similar trends across space as precipitation: discharge is higher to the north and west, and less to the south and east (*Chart 10, Table 7*). Discharge converted to inches also illustrates the trend that substantially less water leaves the watershed as discharge than enters as precipitation - Rantz and Thompson (1967) estimate that, in this region, approximately 50-60 % of precipitation falling in a watershed exits as runoff. Also like precipitation, the percentage of runoff in each month is similar (*Chart 11*); and the proportion of discharge occurring during the 6-month period from November through April ranges from 93.0 % (Santa Rosa Creek) to 97.8% (Salmon Creek).

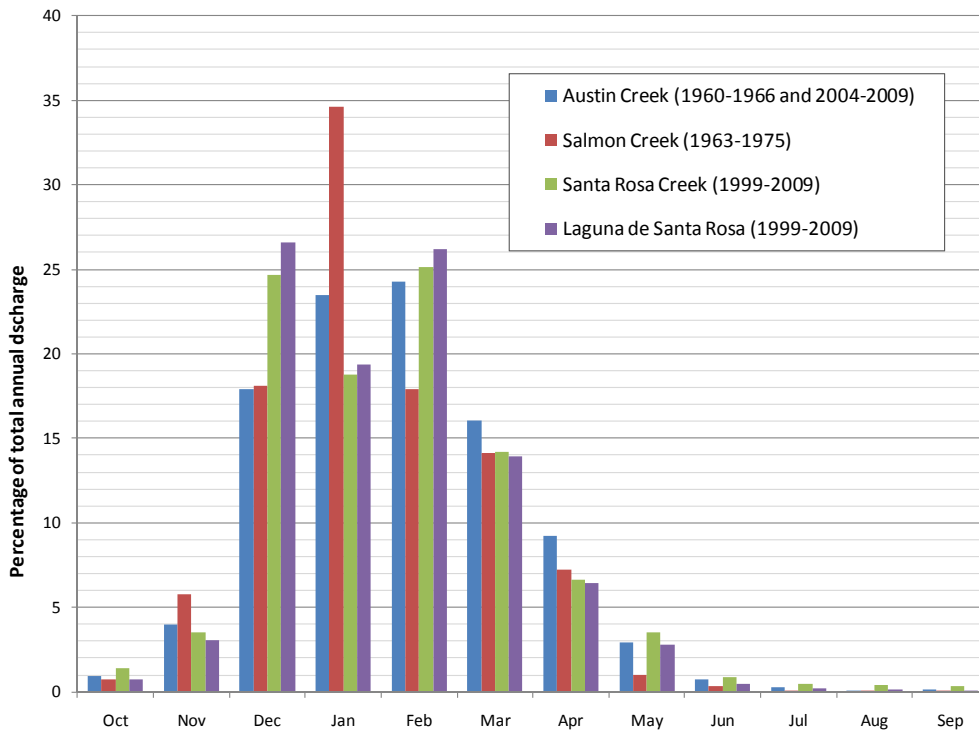
Chart 11. Average Percentage of Discharge Occurring Each Month.

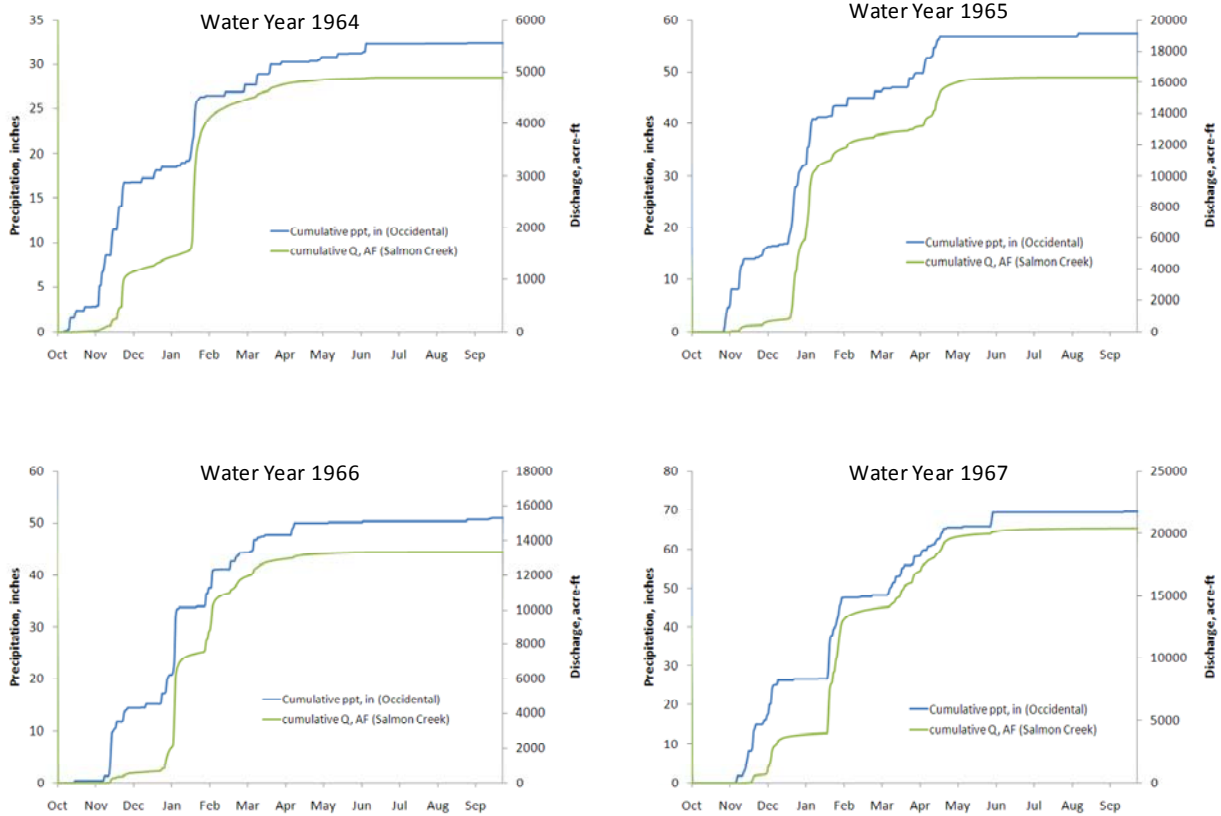
Chart 12 a-d. Cumulative precipitation (Occidental) and discharge (Salmon Creek) through four consecutive years, 1964-1967.

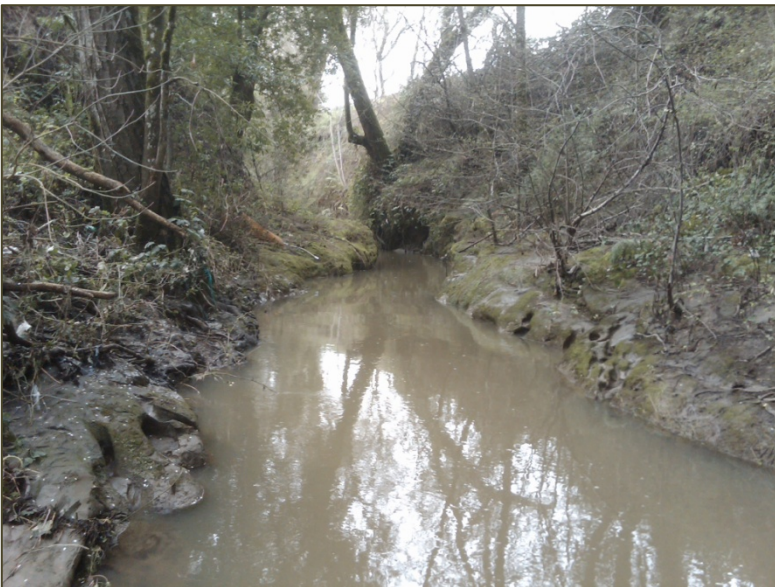
Incised channel. Photo courtesy of Matt O'Connor.

Stream channel incision (entrenchment) is the process whereby a stream erodes its bed, lowering its level over time. It usually occurs in response to changes in the stream channel and/or watershed that result in the stream having excess energy to spend on its bed and banks,

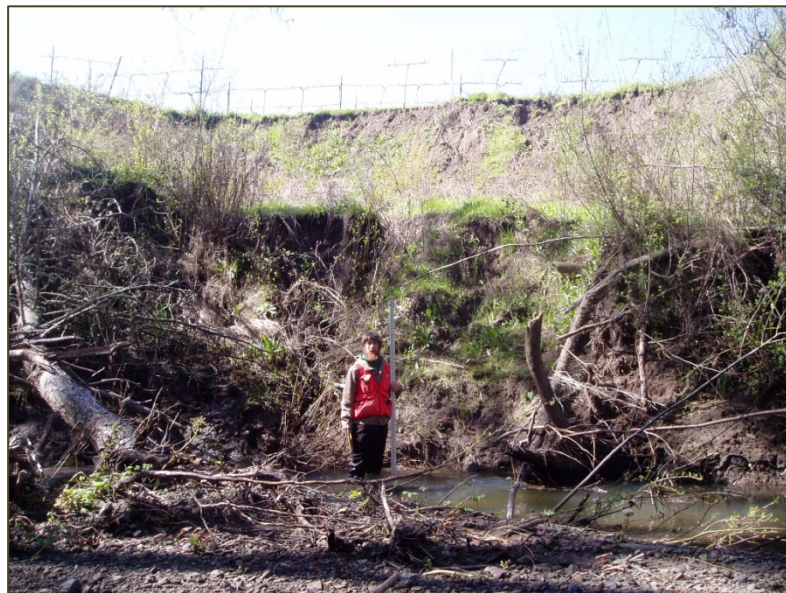
Bank Collapse/Erosion. Photo courtesy of Matt O'Connor.

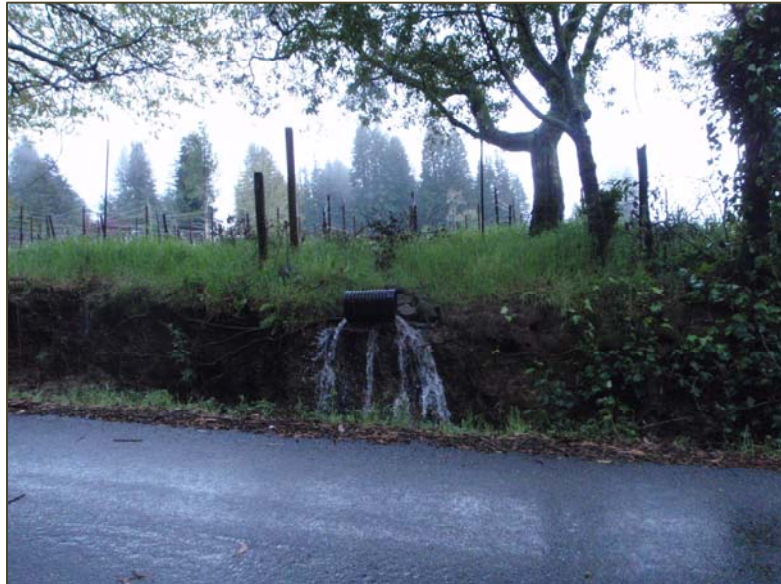
Vineyard drainage. Photo courtesy of Matt O'Connor.

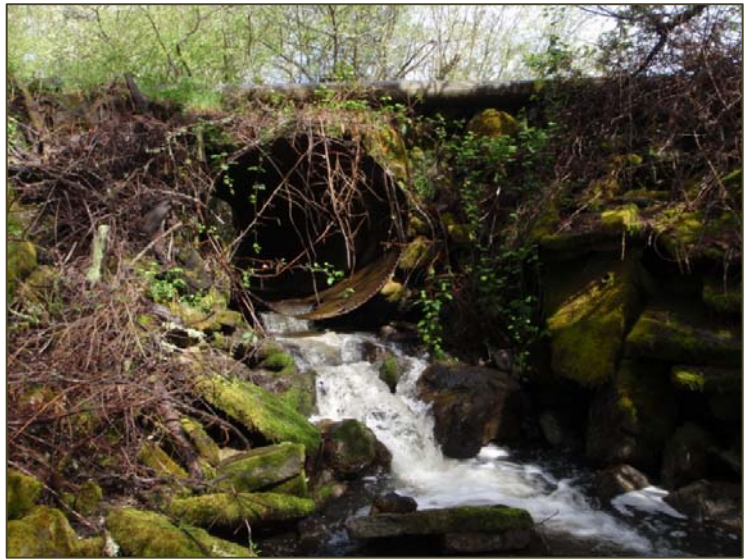
Stream crossing in poor condition on upper Green Valley Creek. This crossing is a barrier to coho salmon passage. Photo courtesy of John Green.

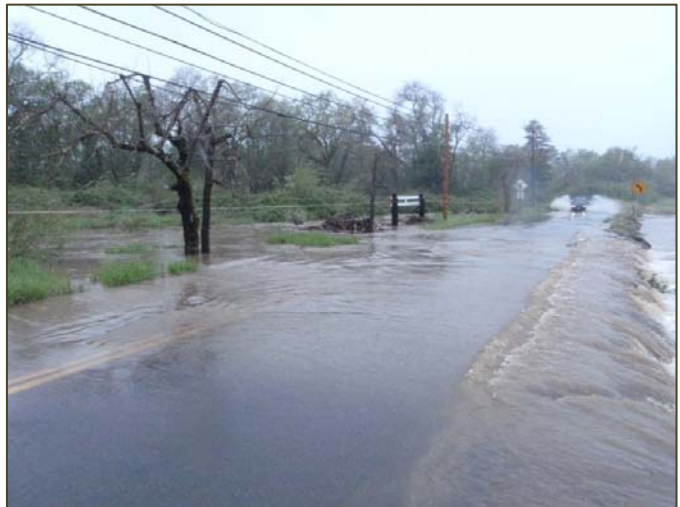
*Flooding on Green Valley Road at the Korbel Vineyard.
Photo courtesy of John Green.*

Additionally, flooding occurs frequently on Green Valley Road near the cemetery

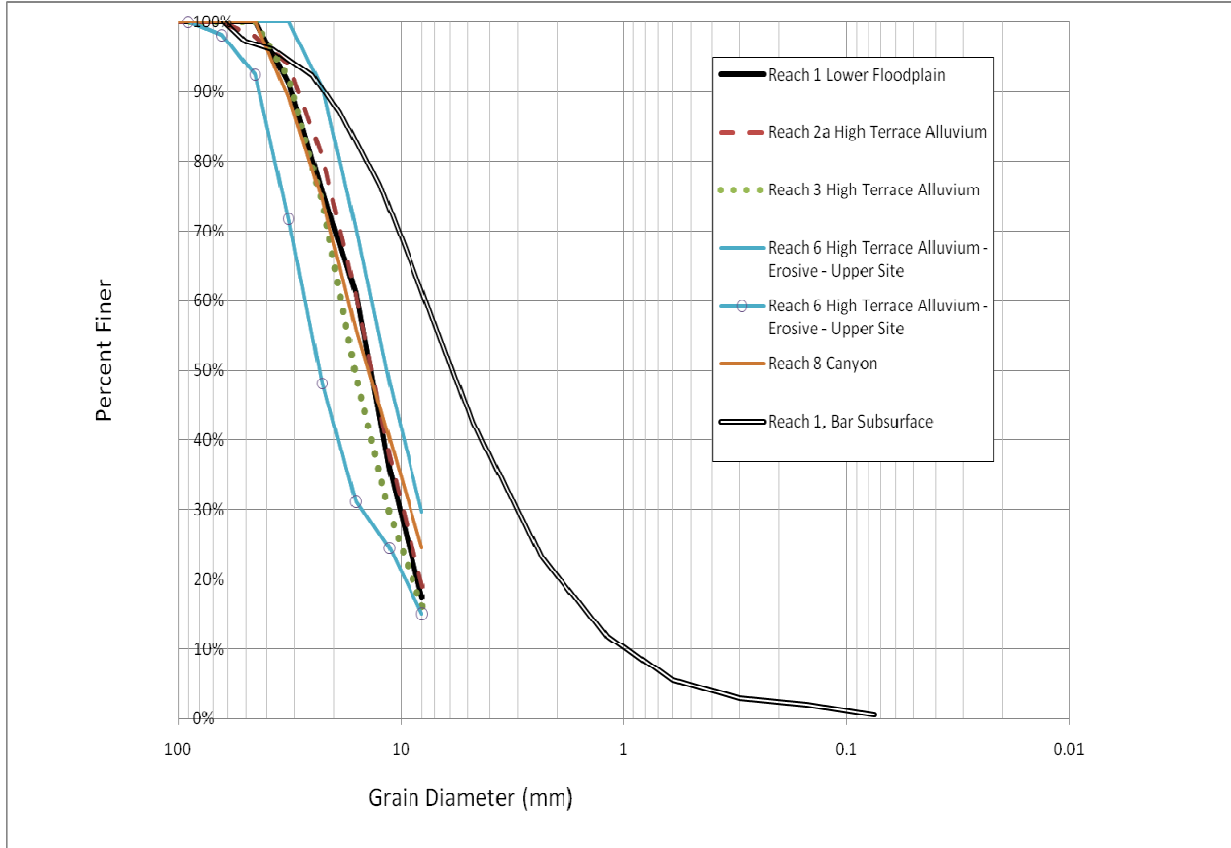
Figure 15: Pebble Count Results for All Reaches
