January 12, 2015

TO: John Green, Gold Ridge Resource Conservation District

FROM: Matt O'Connor, PhD, CEG #2449
Jeremy Kobor, MS, RG #
Michael Sherwood, PG #8839
O'Connor Environmental, Inc.

SUBJECT: Summary of Analysis of Flooding at Green Valley Road and Mitigation Alternatives

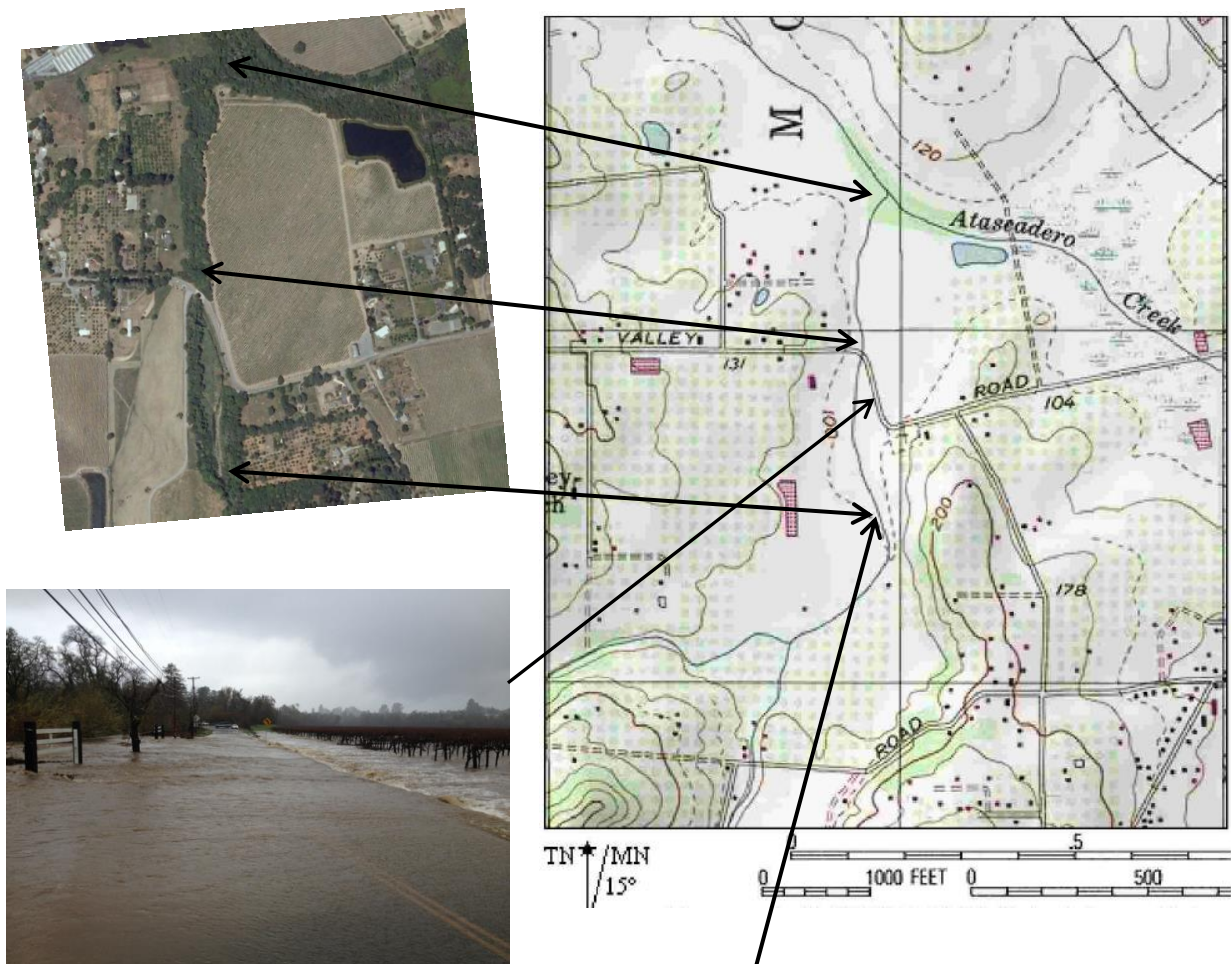
Figure 1. Vicinity map, Green Valley Road at Green Valley Creek. Lower left photo of flooding over Green Valley Road, December 2012 (photo courtesy of John Green)

The portion of Green Valley Road (GVR) that is frequently flooded by Green Valley Creek (GVC) is about 300 ft long and runs parallel to GVC as it approaches the bridge crossing of GVC (Figure 1). The confluence of Green Valley Creek (drainage area 6.1 sq. mi.) and Purrington Creek (drainage area 3.7 sq. mi.) is located about 0.6 miles upstream of the bridge. About 0.3 miles downstream of the bridge, Green Valley Creek joins Atascadero Creek.

The model MIKE FLOOD⁴ was used to simulate flow routing through the channel and floodplain of Green Valley Creek from a point just below its confluence with Purrington Creek to a point just downstream of its confluence with Atascadero Creek (Figure 1). MIKE FLOOD combines a one-dimensional model for

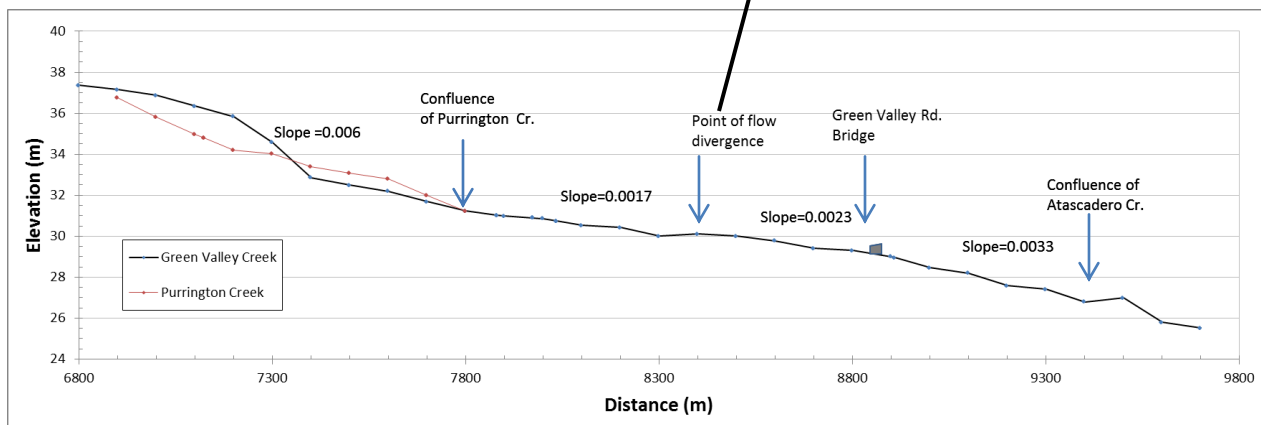
Figure 2. Long profile of Green Valley Creek above Atascadero Creek (note length units in meters).

steepens downstream of the bridge to 0.0033 (Figure 2). The average channel gradients noted above are indicative of reach-scale changes in channel gradient; the change in gradient is gradual.

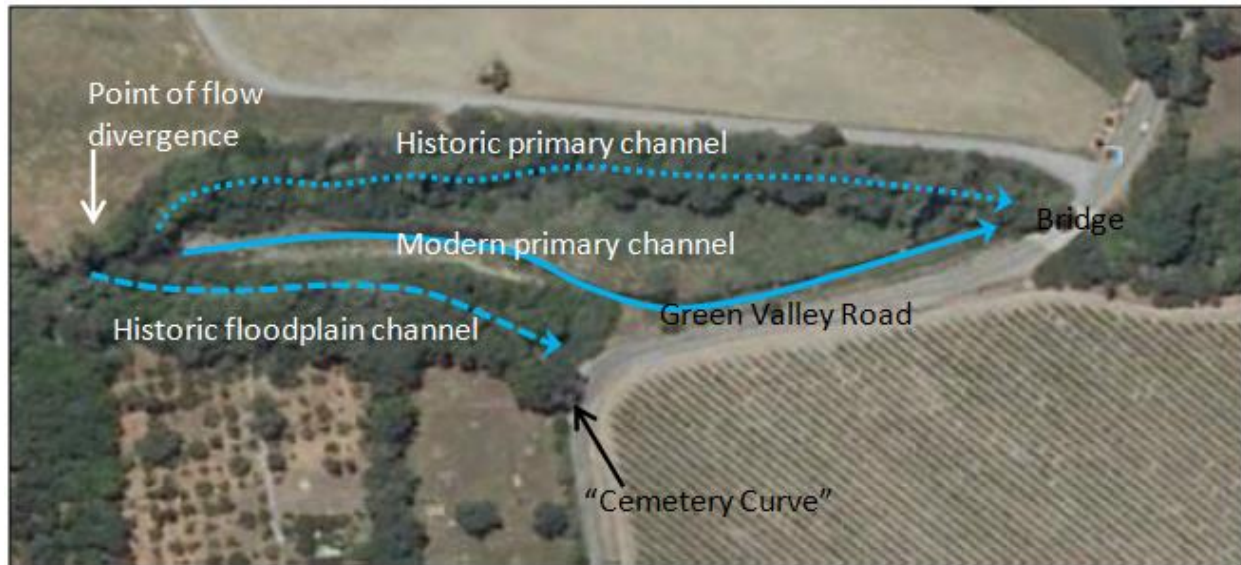
Figure 3. Channels of Green Valley Creek near Green Valley Road Bridge.

During periods of peak stream flow, at the point of flow divergence, lower bank height allowed for lateral spread of flow into a historic swale-like floodplain channel. At present, this historic floodplain channel remains active; however, the historic primary channel has been abandoned and a new (“modern”) primary channel has become established (Figure 3).

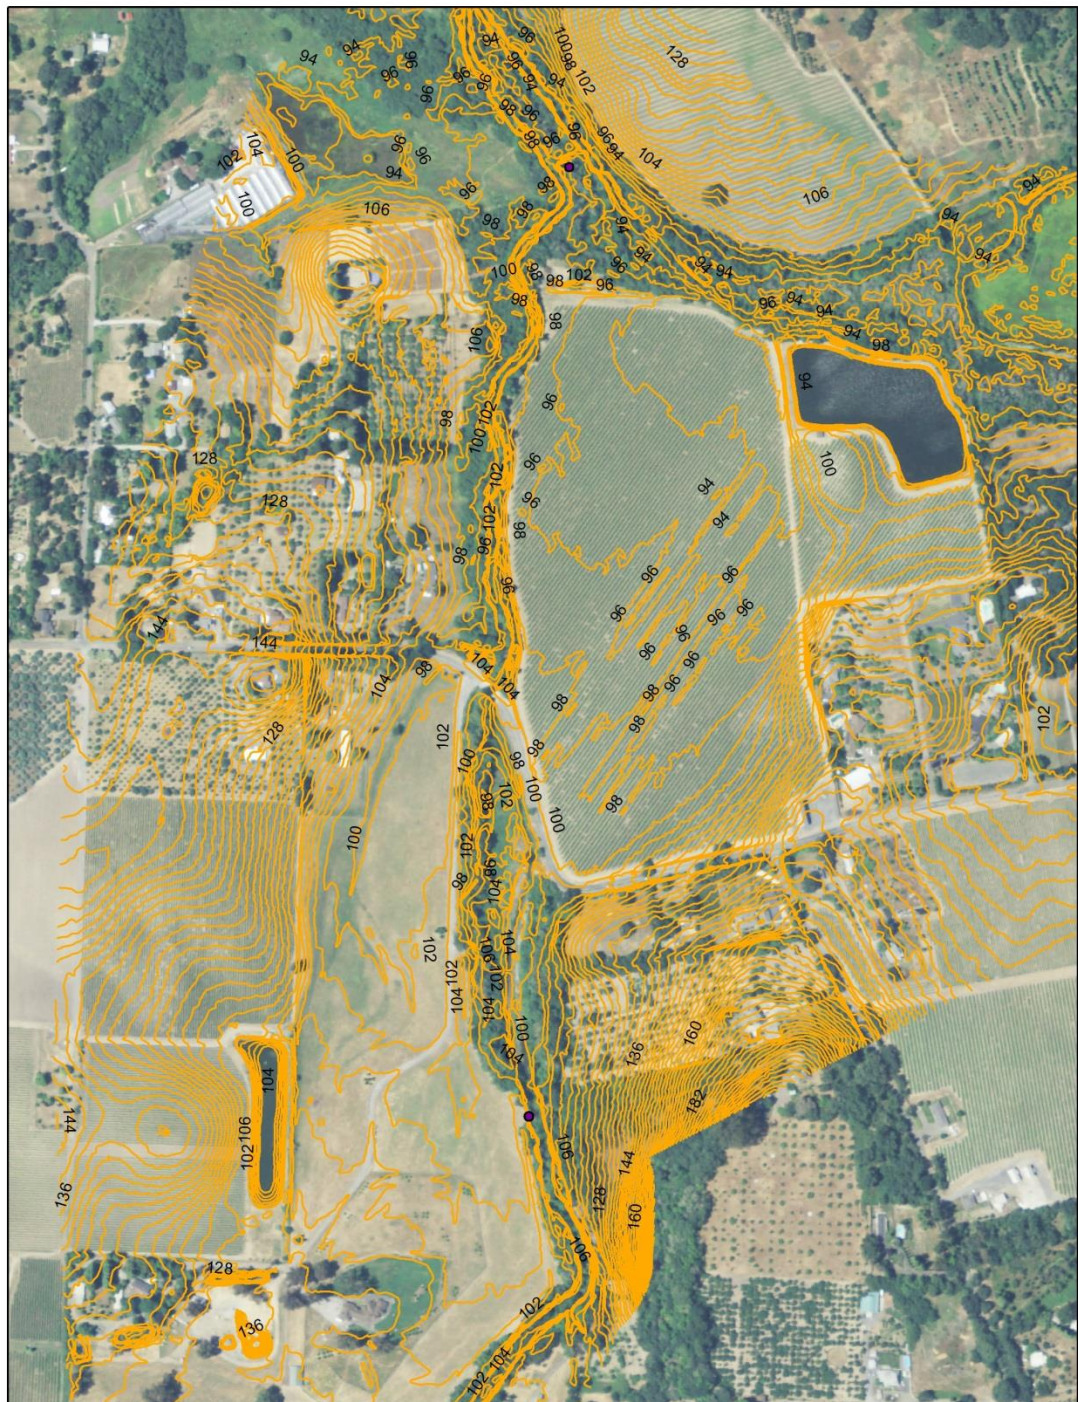
Figure 4. Topographic map of Green Valley Creek and Atascadero Creek study area.

Note: Elevations contours < 94 ft are not generally labeled except for the 92 ft contour in the northeast corner of the vineyard adjacent to the reservoir and Atascadero Creek.

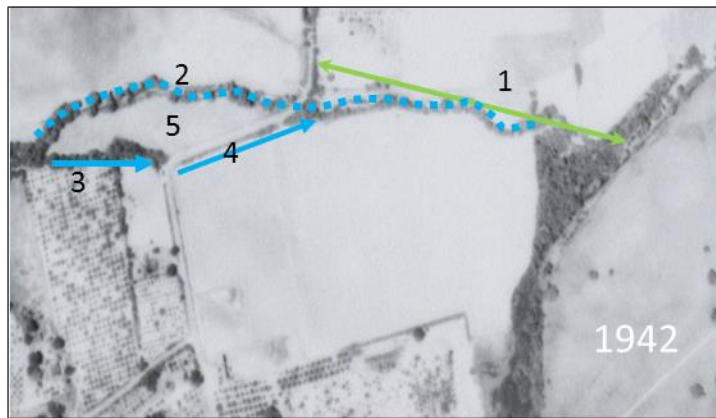
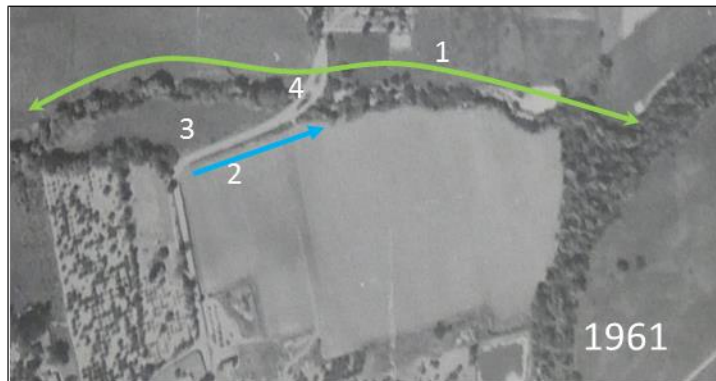
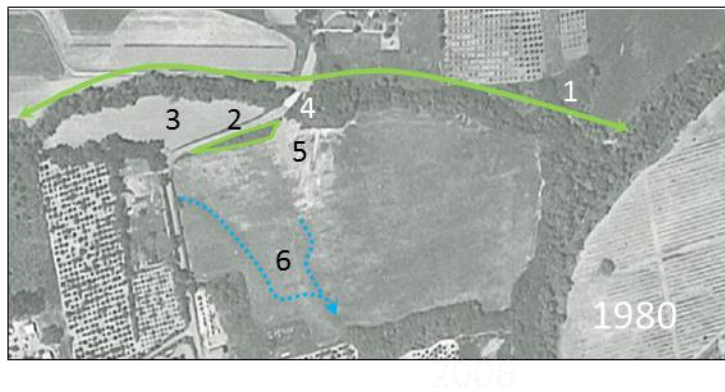
1. Sparse riparian vegetation along Green Valley Creek (GVC) and at confluence with Atascadero Creek (AC); (green line).
2. Primary channel of GVC (dotted blue line).
3. Historic floodplain channel (HFC) (blue line) diverges from mainstem GVC and flows through riparian veg. to “Cemetery Curve”.
4. HFC flows routed in ditch (blue line) adjacent Green Valley Rd (GVR) back to mainstem GVC downstream bridge on east bank.
5. Agricultural field between GVC and GVR.

1. Growth/expansion of rip. veg. along GVC and at confluence with AC (green line).
2. HFC flows routed in ditch (blue line) adjacent GVR back to GVC downstream bridge.
3. Ag. field between GVC and GVR.
4. Second bridge span added upstream of historic bridge span.

1. Growth/expansion of rip. veg. along GVC and at confluence with AC (green line).
2. Growth/expansion of rip. veg (green polygon) in ditch adjacent GVR
3. Ag. field between GVC and GVR.
4. Modern bridge configuration built 1968; 14ft elevation difference from bridge deck to channel in 1968
5. Indications of fill (light patches) at downstream end of ditch near bridge.
6. Indications of flow across southeast corner of field east of GVR (dotted blue lines).

Figure 5a. Summary interpretation of historic aerial photography, 1942-1980.

The recent history of channel and floodplain conditions in the vicinity of Green Valley Road and the Atascadero/Green Valley Creek confluence was investigated primarily using historic aerial photography, supplemented by information from local observers and available State and County records regarding the bridge and streambed alterations in the reach upstream of the bridge. Following is a narrative describing our understanding of past changes in channel conditions and the evolution of the channel and floodplain in this area as it exists at present. Significant developments are enumerated and discussed below. The discussion is illustrated by aerial photo interpretation summarized in Figure 5a & 5b.

2. Gradual shift in the pattern of flow in Green Valley Creek near the Green Valley Road Bridge. As shown in Figure 5a, the change in flow pattern is believed to have occurred as a result of the colonization of riparian areas by dense native and exotic vegetation and gradual sedimentation in Atascadero Creek and Green Valley Creek at their confluence beginning between 1942 and 1961. This initiates gradual sedimentation in Green Valley Creek above the confluence of Atascadero Creek.

In 1942 and 1961, Green Valley Creek occupies its historic primary channel, and a historic floodplain channel diverges from the main channel and flows along the base of the hill occupied by Green Valley Cemetery. The historic floodplain channel appears to be routed across or under Green Valley Road at Cemetery Curve in a ditch on the east side of Green Valley Road, rejoining Green Valley Creek downstream of the bridge.

In 1980, the vegetation in this ditch has grown, and there is a subtle indication of flow to the northeast into the field north and east of Cemetery Curve (Fig. 5a). Sedimentation of Green Valley Creek has presumably begun to affect channel capacity by this time.

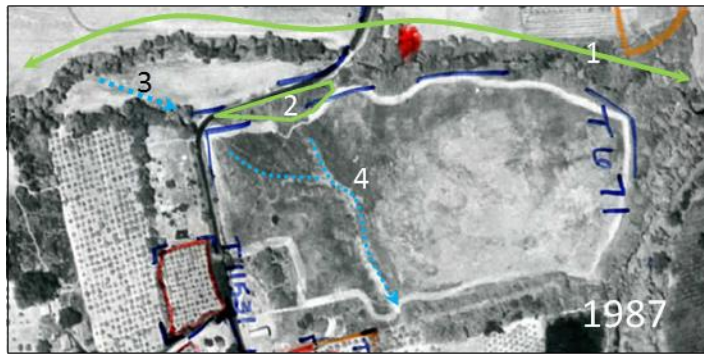
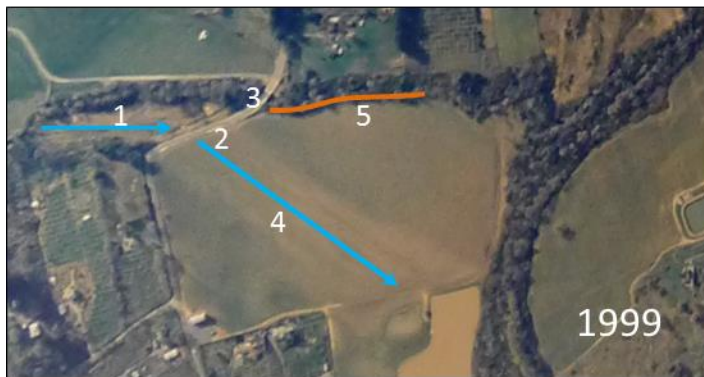
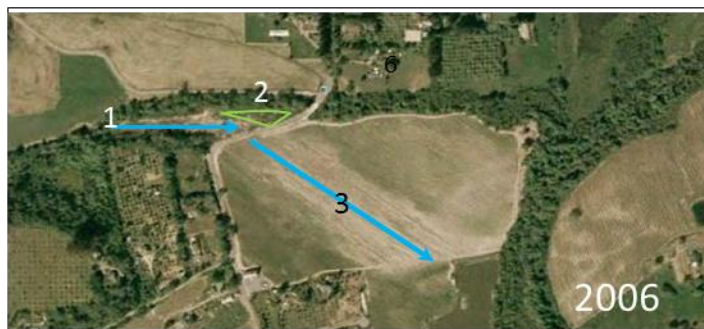
1. Growth/expansion of rip. veg. along GVC and at confluence with AC (green line).
2. Growth/expansion of rip. veg. in ditch adjacent GVR (green polygon).
3. Indications of overbank flow across ag. field between GVC and GVR (dashed blue line).
4. Development of channel across field east of GVR consistent with interruption of ditch flow c. 1980 (dashed blue line).

1. High flows routed in modern primary channel alignment through former ag. field from point of flow divergence (blue line).
2. Elimination of ditch adjacent GVR.
3. Aggradation of 6.5 ft at bridge since 1968.
4. Evidence of broad flood flow path across vineyard field east of GVR consistent with flood flow patterns c. 2012.
5. Earthen levee (construction date unknown)

1. Significant channelized flow across former ag. field in modern primary channel alignment (blue line)
2. Establishment of new riparian/wetland vegetation (green polygon) in former ag. field
3. Evidence of broad flow path across vineyard field east of GVR consistent with flood flow patterns c. 2012.

Figure 5b. Summary interpretation of historic aerial photography, 1987-2006.

In 1987, one year after a historic flood on the Russian River, there appear to have been significant changes in flow patterns (Fig. 5b). Distinct channels and substantially expanded stands of riparian vegetation are present in the field east of Green Valley Road. The strip of land between Green Valley Creek and Green Valley Road (a farm field or pasture through 1980) shows signs of overbank flow from Green Valley Creek from west to east downstream of the point of flow divergence.

In 1999, a new path of stream flow of Green Valley Creek appears in the alignment of the modern primary channel (Fig. 5b). The evolution of the channel in this area was influenced by efforts by the landowner to repair stream bank damage and to harvest accumulated silt, sand and gravel by agreement with California Department of Fish & Game (CDFG). The field east of Green Valley Road in 1999 is under cultivation as a vineyard (this change occurred prior to 1993), and evidence of flood flows across Green Valley Road and the vineyard to the northeast is readily apparent.

Following regional flooding that occurred Dec. 31, 2005, it is clear in the 2006 photograph (Fig. 5), that Green Valley Creek’s flood flows were routed through the modern primary channel, across Green Valley Road, and across the vineyard to the northeast toward the topographic low point near a reservoir at the edge of Atascadero Creek. It is likely that sedimentation during this event contributed to the in-fill and abandonment of the historic channel of Green Valley Creek. Riparian vegetation has begun to grow in the former farm field adjacent to and west of Green Valley Road between Cemetery Curve and the bridge. The 2006 photo reasonably represents current conditions, however, the extent and density of riparian vegetation in and near the new channel of Green Valley Creek has significantly increased since that time. Flooding of Green Valley Road has become more frequent; a local property owner observes that as of 2012, one inch of rain in a 24-hour period produces enough runoff to overtop Green Valley Road.

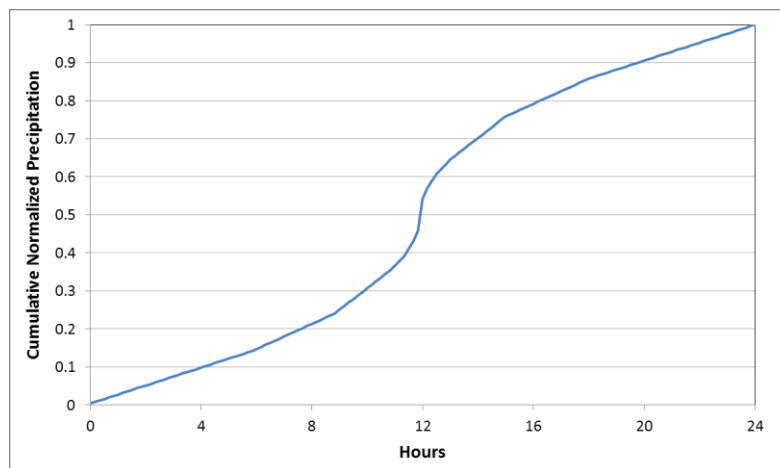
Figure 6. Normalized cumulative precipitation curve for 24-hour design storms for input to hydrologic model.

Maximum accumulated 24-hour rainfall depths for the 2-, 10- and 100-yr storms were 120, 200 and 280 mm, respectively. These values are equivalent to about 4.7, 7.9 and 11.0 inches of rainfall.

The watershed hydrologic model produced a simulated flow hydrograph (Figure 7) based on the synthesized rainstorm inputs shown in Figure 6. The 2-year rainstorm produced peak stream flow of about 951 cfs; compared to USGS predictions (Table 1), this is about 50% higher than the mean estimate for a 2-year recurrence interval flow, but well within the range of prediction. Observations from two recent storms on 2/9/2014 and 12/11/2014 provide a means of qualitatively evaluating the accuracy of the flow estimate. The flood extent and degree of road overflow predicted with the hydraulic model for the 951 cfs flow was greater than what was observed during the February 2014 storm and somewhat less than what was observed during the December 2014 storm. Rainfall totals (24-hr) at the CIMIS Santa Rosa gauge located east of Sebastopol (the nearest hourly gauge) for these two events were 4.3 and 4.2 inches respectively. These rainfall totals are close to the 2-yr estimate of 4.7 inches and the qualitative comparison of simulated flood extents and the observations from the two recent events suggest that the model estimate of the 2-yr flow is reasonably accurate.

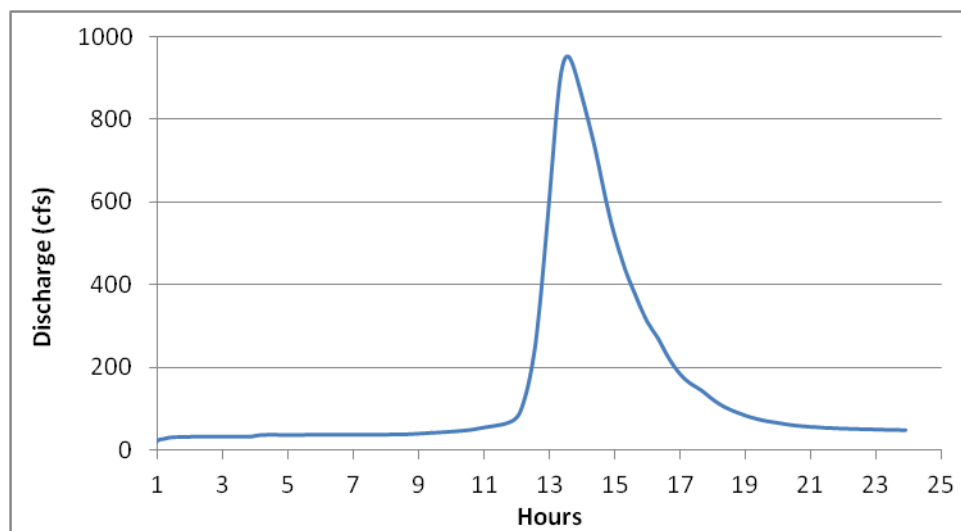
Figure 7. Green Valley Creek simulated hydrographs for the 2-year synthesized rainstorm.

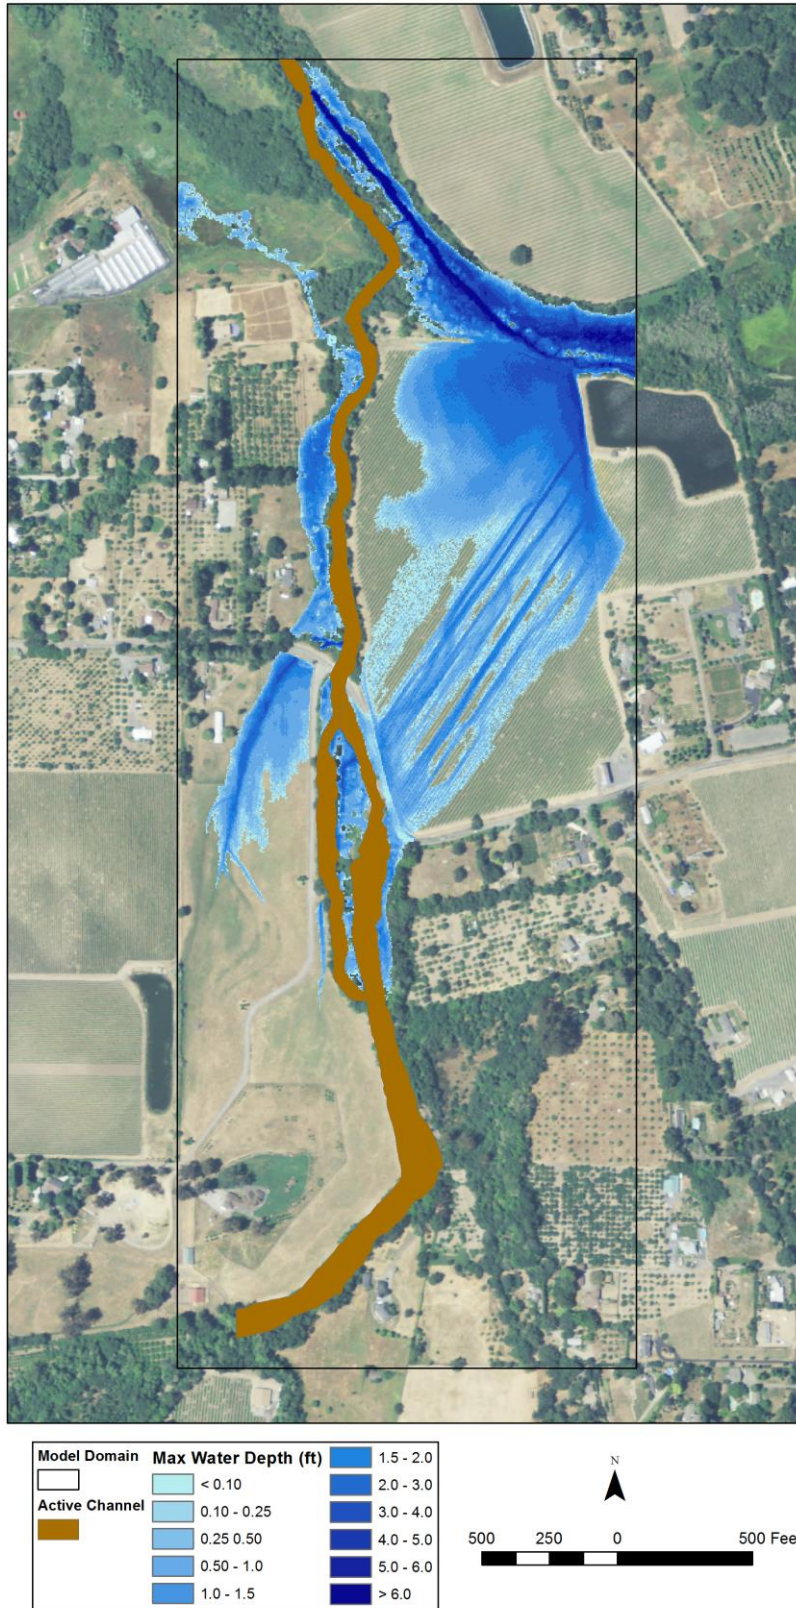
Figure 8. Baseline Flood, 2-year Recurrence Interval

The simulated distribution and maximum depth of flow on the floodplain under existing conditions for the 2-year event is shown in Figure 8. At maximum, approximately 443 cfs (47% of the total flow) exits the channel on the right bank and flows over Green Valley Road and into the vineyard along the reach upstream of the bridge. The bridge itself does not overtop, however maximum water surface elevations are above the bridge soffit. The vineyard floods both from the road overtopping and, along its northern edge, from backwater flooding caused by high water surfaces in Atascadero Creek. Portions of the pasture on the left (west) bank floodplain become inundated due to backwater flooding through the culvert located just west of the bridge. The patterns of flooding depicted in Figure 8 (peak discharge of about 951 cfs) are consistent with that observed during the two recent events in February and December of 2014. In particular, the extent of submergence over Green Valley Road, the location and extent of flow to the northeast across the vineyard, and the ponding of water in the northeast corner of the vineyard in the Atascadero Creek floodplain were observed during both events.

The approach to evaluating alternative flood mitigation strategies was developed in consultation with Gold Ridge RCD. This process involved conceptualizing alternatives, devising a means to represent them in the hydraulic model, running the model for each alternative scenario, and evaluating the alternative's effectiveness. The primary means to evaluate effectiveness of flood mitigation was by comparing model results for water surface elevations and maximum extent and depth of flooding to that for existing conditions as shown in Figure 8.

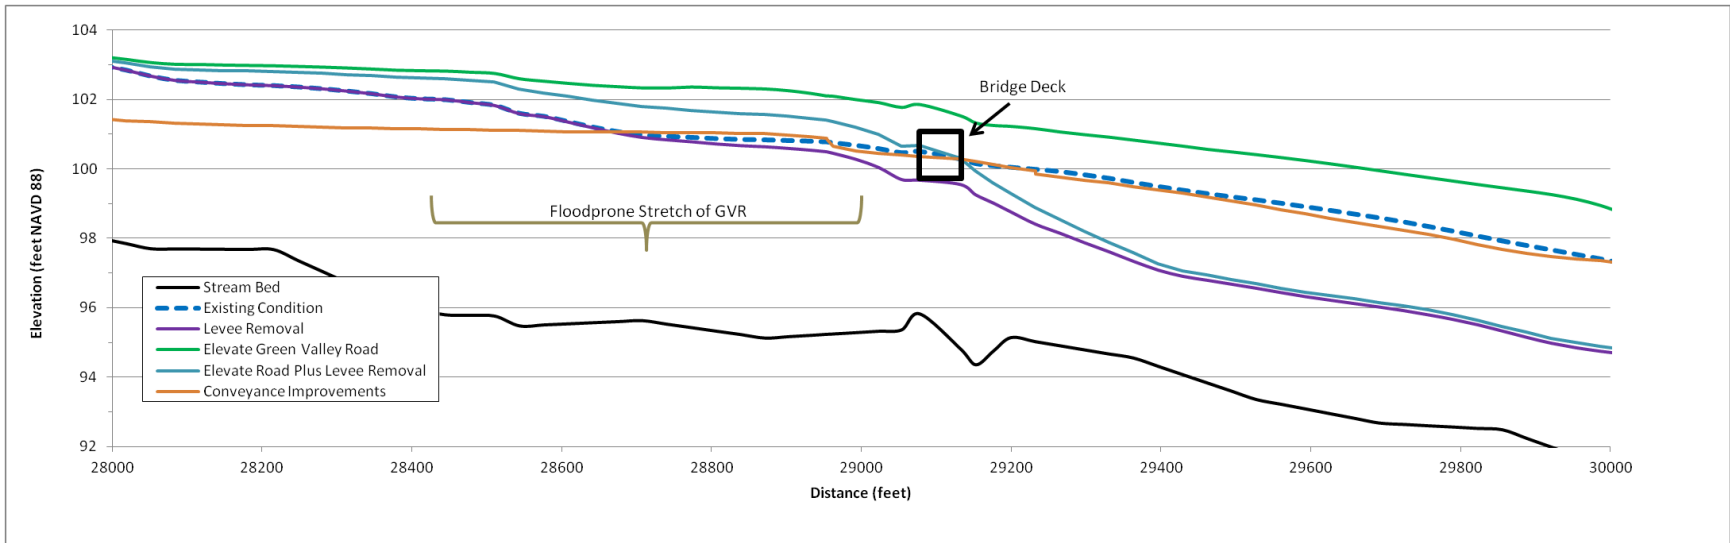
Figure 11. Comparison of Existing Conditions Water Surface Profiles and Water Surface Profiles for Various Alternatives Including Elevating Green Valley Road, Removing the Downstream Levee, and Conveyance Improvements, 2-year Flow Event

Maximum water surface elevations increase (relative to existing conditions) by 0.5 to 1.0-ft upstream of the bridge and 1.0 to 1.5-ft downstream of the bridge (Figure 11). The cessation of road overtopping results in a significant reduction in flooding in the southern portion of the vineyard, however significant flooding still occurs in the northern portion of the vineyard owing to backwater flooding from Atascadero Creek (Figure 9). In the western pasture significant increases in flood depths and flood extent occur as a result of the higher road grade. This phenomenon results from the combined effects of less water overtopping the road and the inability of the system to convey this water to the reach below the bridge caused by the backwater at the confluence with Atascadero Creek and the limited conveyance at the bridge which results in increased overbank flow along the left bank.

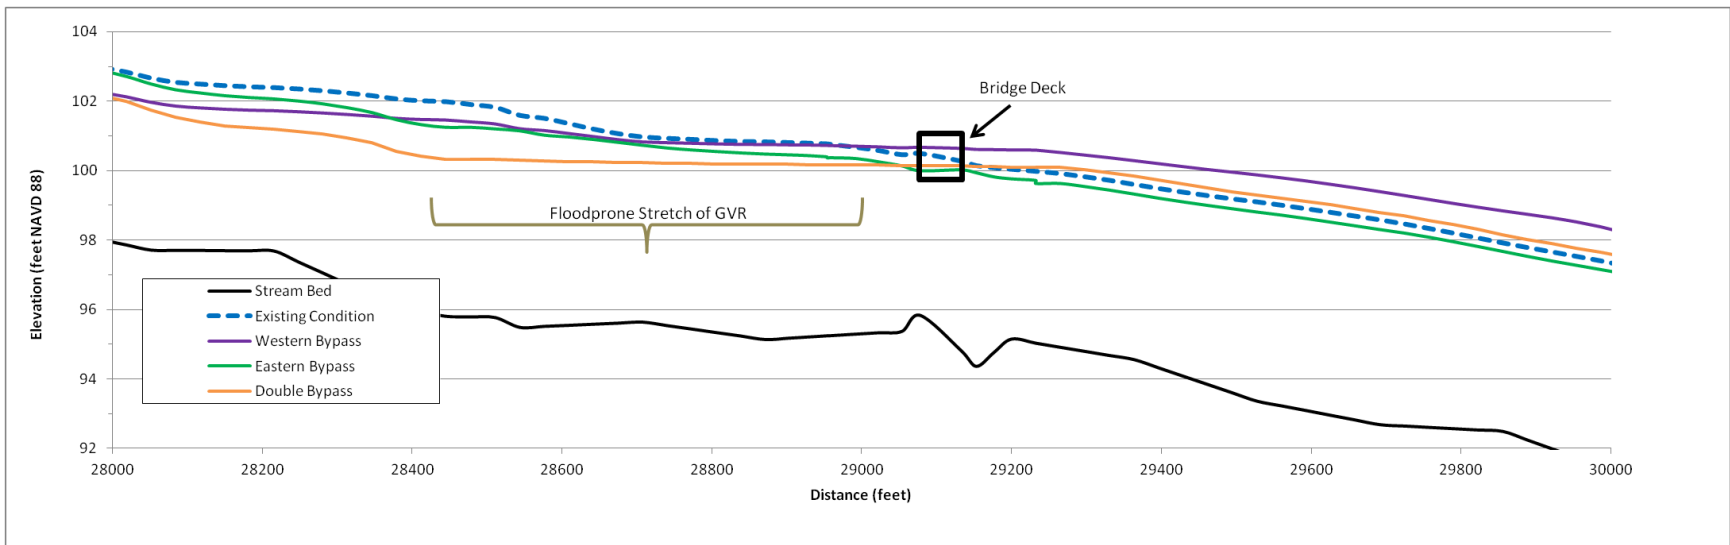
Figure 12. Comparison of Existing Conditions Water Surface Profiles and Water Surface Profiles for the Various Bypass Alternatives, 2-year Flow Event

A maximum discharge of 429 cfs (45% of the total flow) entered the eastern bypass through the lateral box culverts. The bypass channel had sufficient capacity to handle this flow over most of its length. High backwater conditions from Atascadero Creek result in overtopping of the bypass channel at the downstream end. This overtopping does not increase vineyard inundation beyond that experienced under existing conditions because this area becomes inundated from backwater flooding regardless. The bypass was successful at partially mitigating the 2-yr road overflow and the peak overflow was reduced to 79 cfs (a reduction of 82% over existing conditions) (Figure 14). Peak water levels decreased by 0.4 - 0.7-ft relative to existing conditions throughout the flood-prone reach upstream of the bridge. Small reductions in water level (~0.2-ft) also occurred downstream of the bridge (Figure 12).

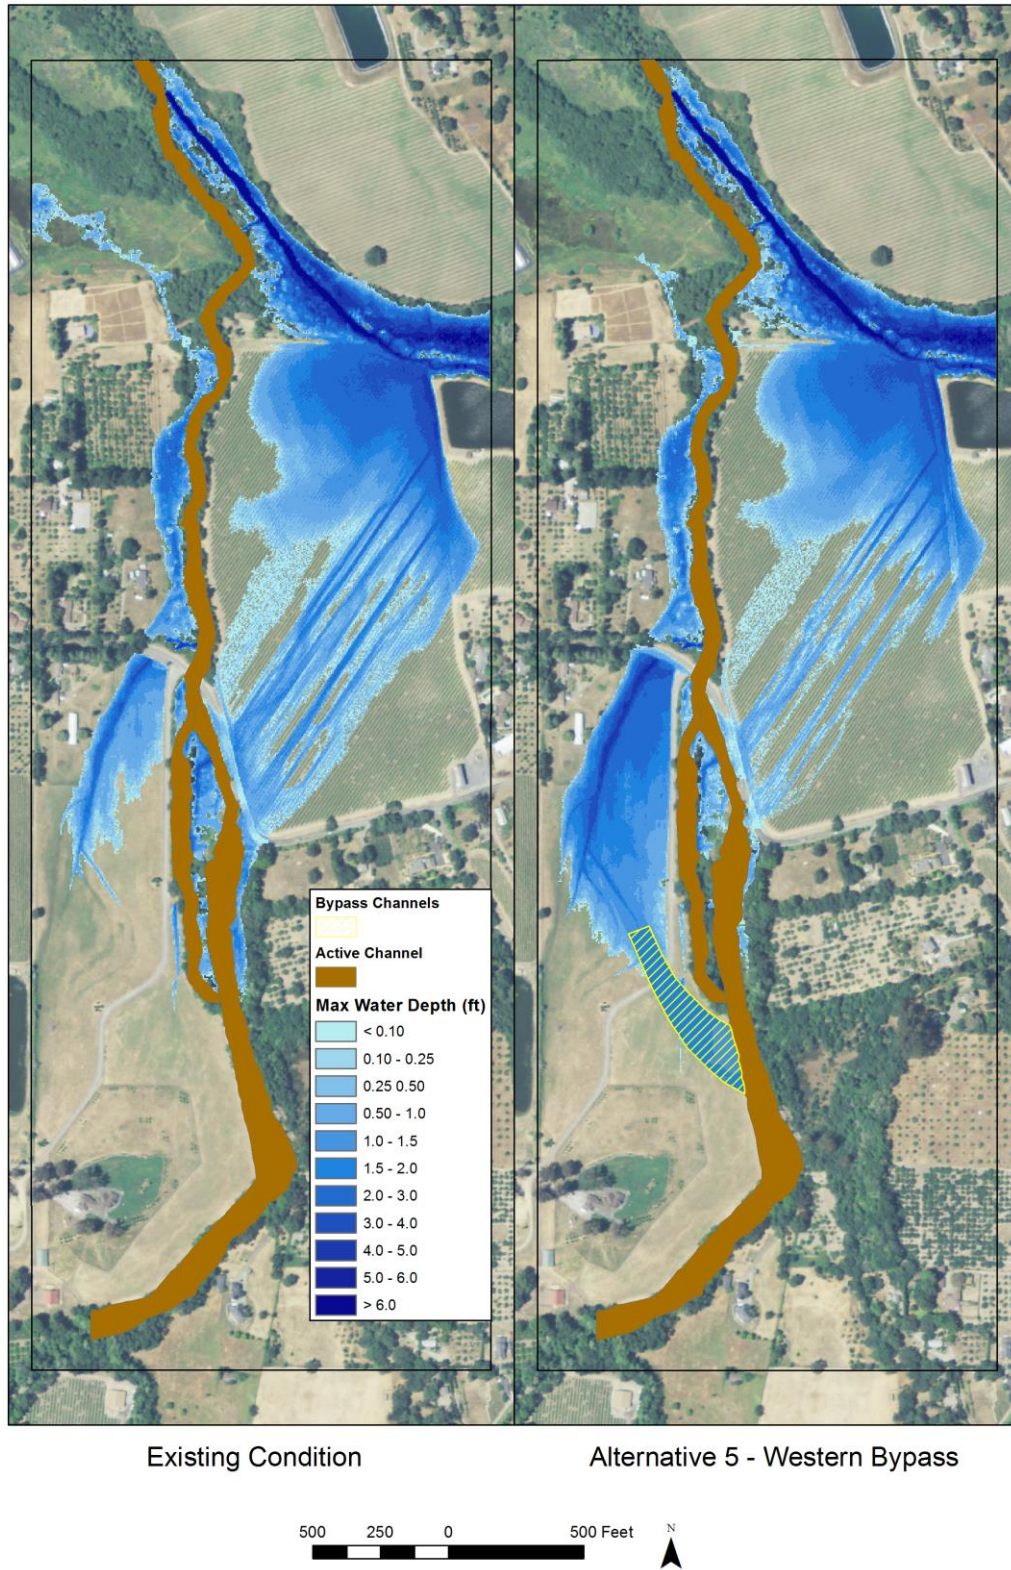
Figure 15. Comparison of Existing Conditions Flooding and Alternative 5 Flooding, 2-year Flow Event
