Salmon Creek Watershed Sediment Reduction and Water Conservation Project

Quarterly Water Quality Monitoring Report, June to December, 2011

Prepared by Gold Ridge Resource Conservation District

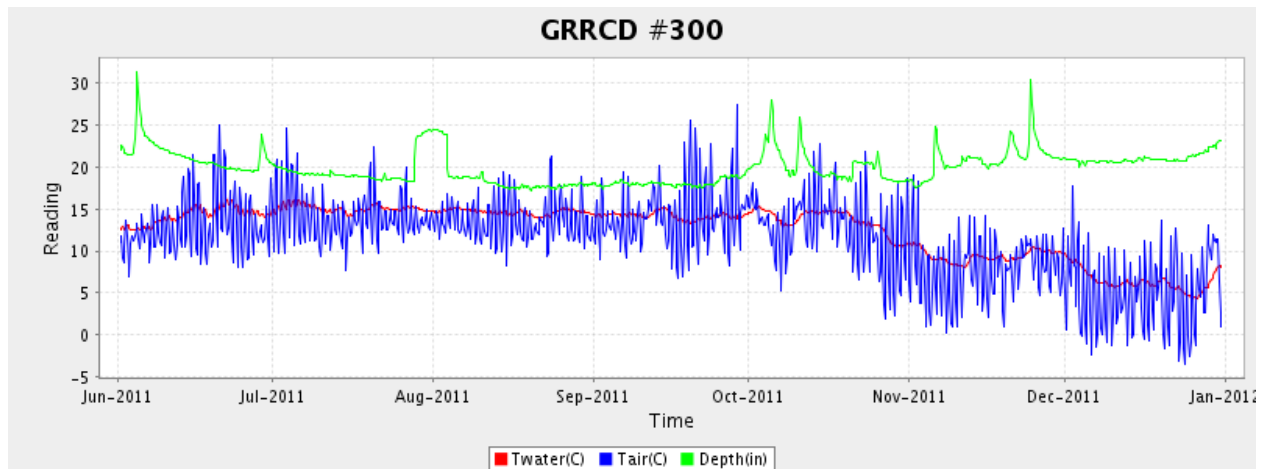
Figure 1: Hydrograph of Salmon Creek from June 1 to December 31, 2011. This graph illustrates Salmon Creek streamflow throughout the reporting period. Note that despite the rain events in October and late November the fall was a relatively dry period with short lived responses in water depth and cold temperatures. An unusual rounded peak in stream depth occurred in the early part of August and was not due to rainfall but caused by the placement of a V-notch weir just above the stage gauge to measure the volume of water in the creek. These measurements were taken by scientists from Prunuske Chatham, Inc. who are monitoring water supply in Salmon Creek.

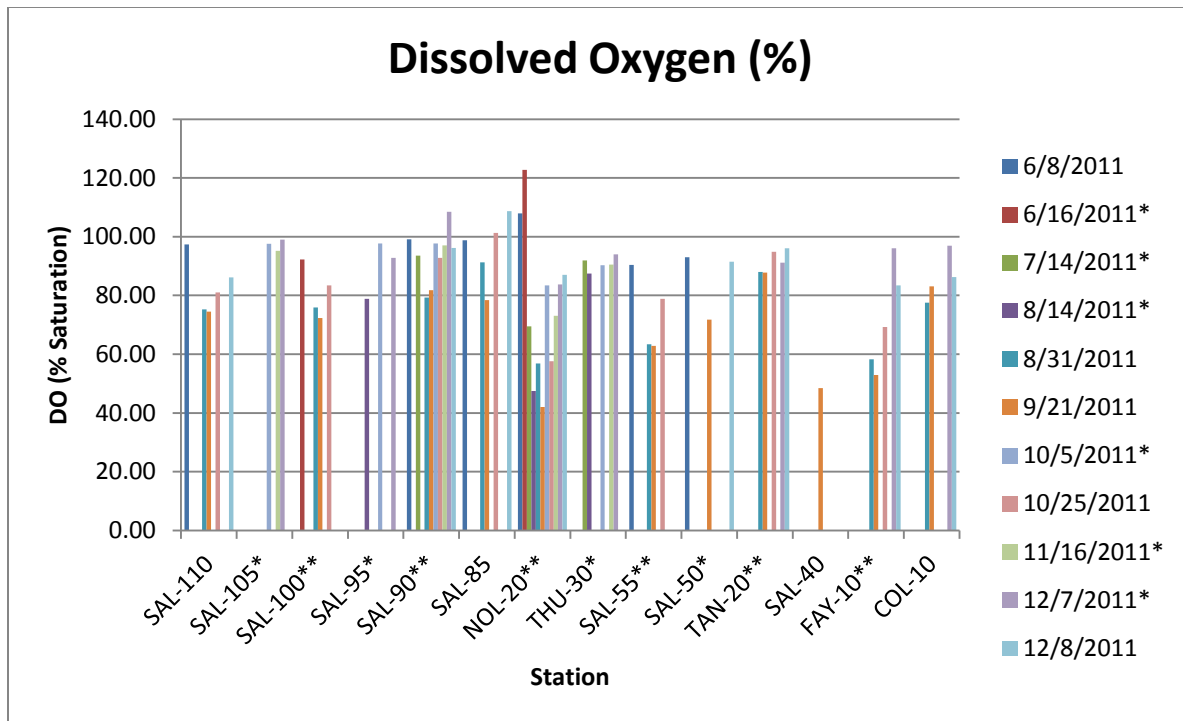
During the drier summer and fall months, creek levels are low and stream flow can become disconnected which creates natural conditions in which dissolved oxygen levels would be

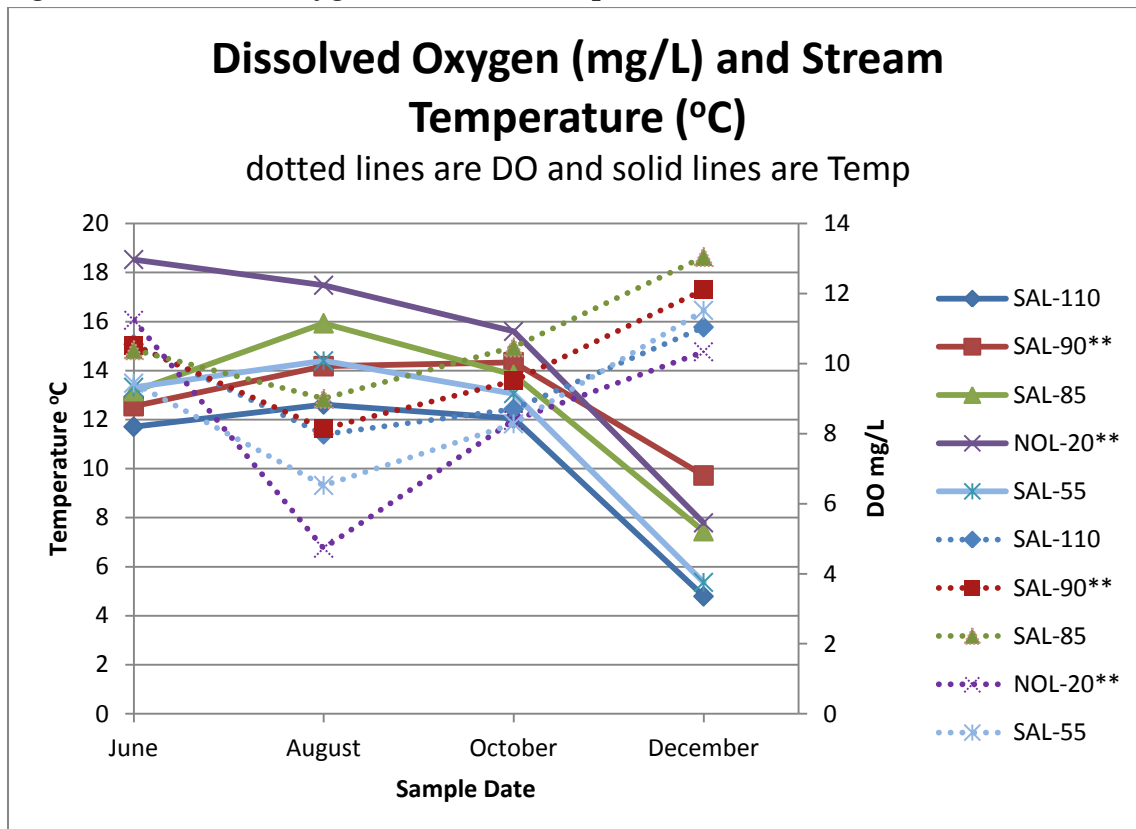
Figure 7c. Dissolved oxygen and stream temperature in Salmon Creek.

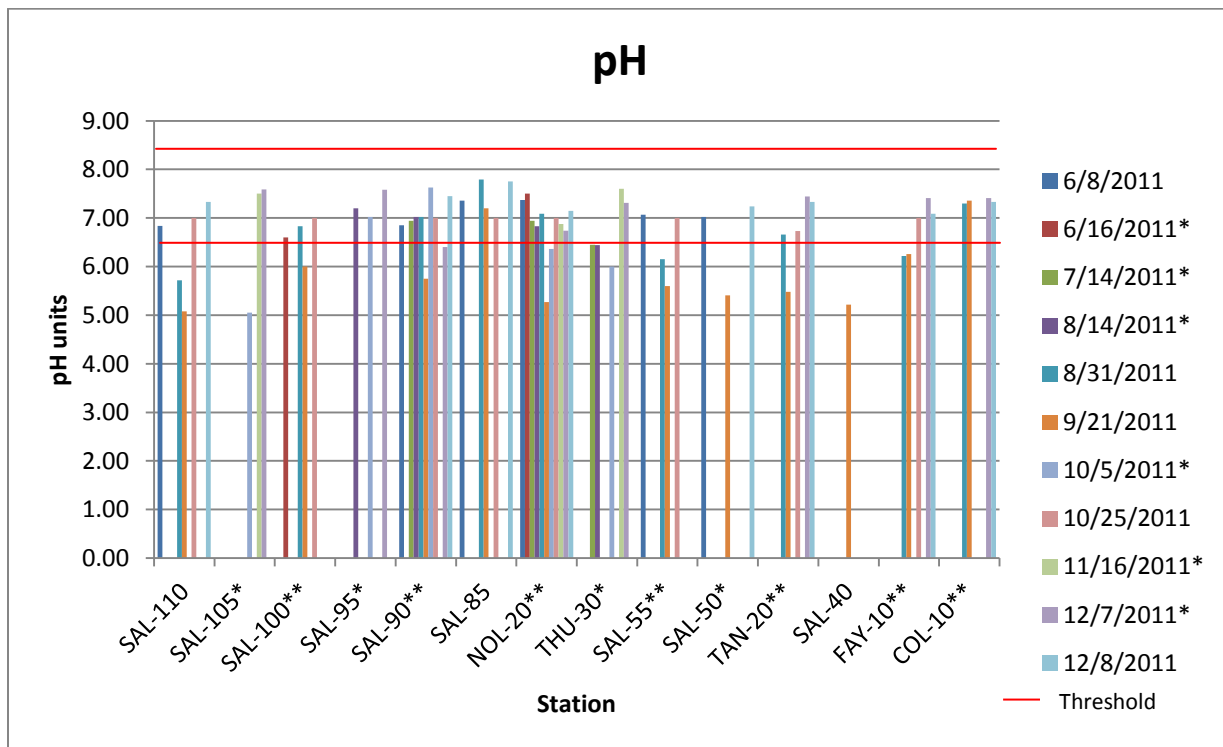
Figure 8: pH Measurements

Several stations had pH measurements below the Water Quality Objectives during the dry months of late summer and early fall with the lowest level (5.05) recorded at station SAL-105 in the town of Bodega by the volunteers with the Salmon Creek Watershed Council (Figure 8). The acidic conditions improved after the first significant rainfall in early October. It is also important to note that during this time we were experiencing difficulties with the pH probe and when samples were checked with pH strips, they were closer to 7, so it is probable that the low levels of pH can be attributed to the probe rather than creek conditions. The pH probe was sent back to the manufacturer and replaced with a new one.

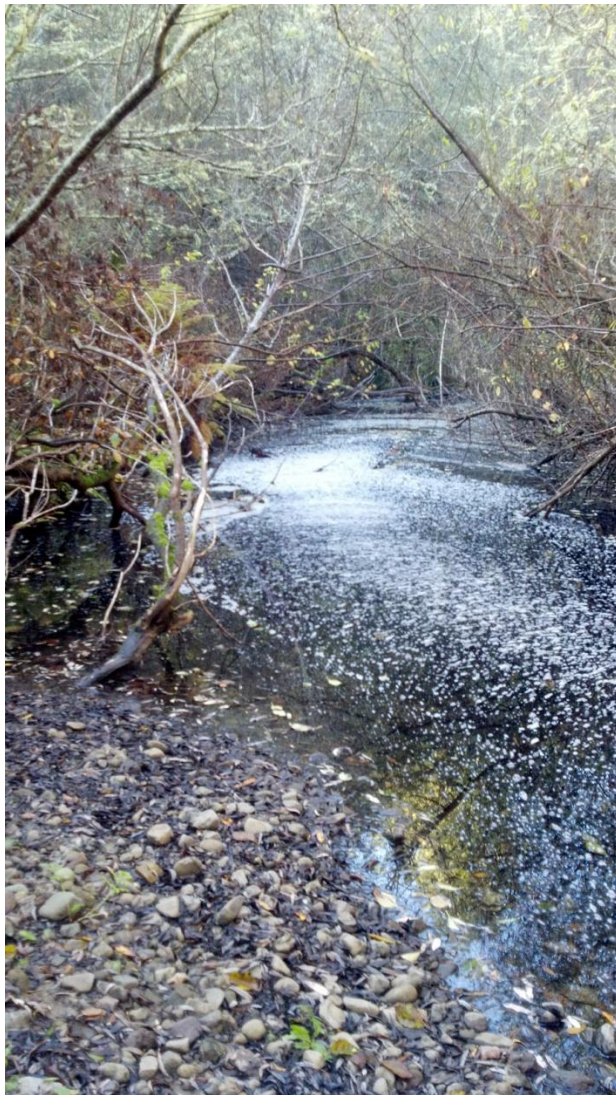
This photo taken in Dec. 2011 of the lower section of Salmon Creek illustrates the presence of foam possibly from detergent or other phosphates in the water.

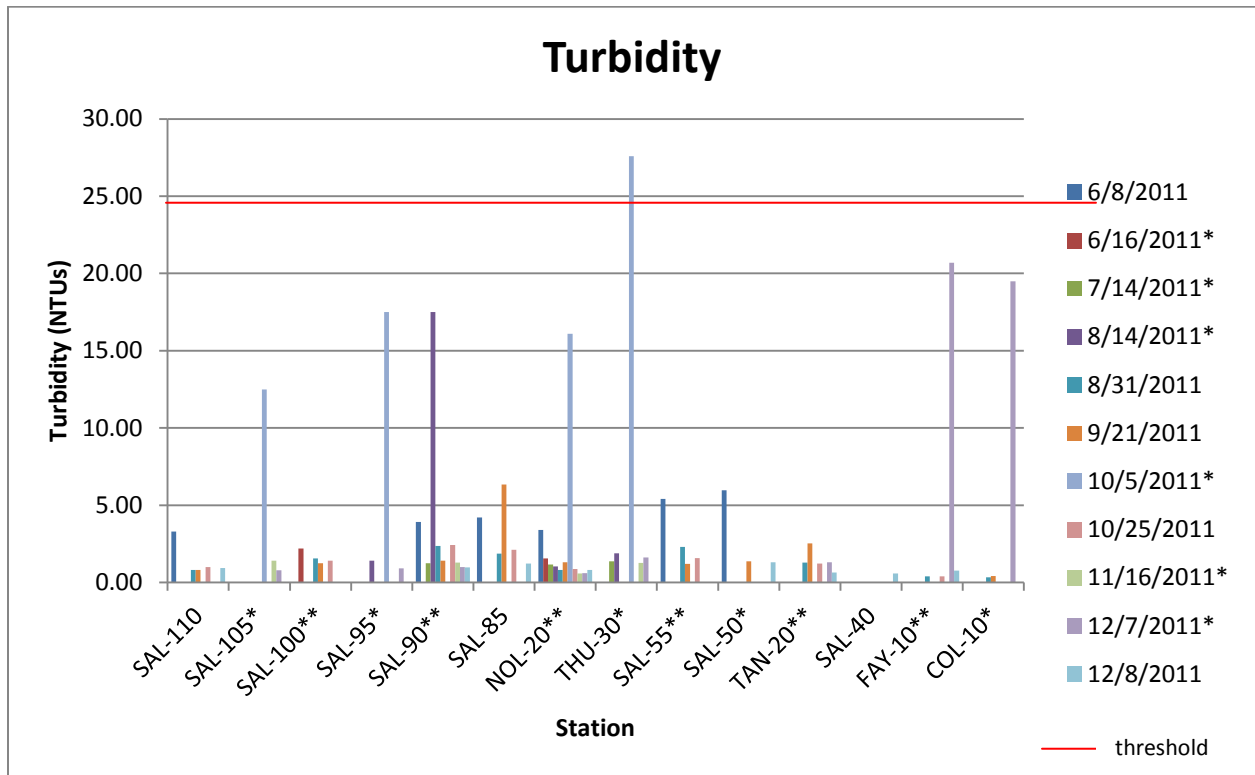
Figure 10: Turbidity. Turbidity levels were well below the acceptable threshold for this time of year except for a one station at Thurston Creek and Joy Road.
